## TECHNICAL MEMORANDUM

### GORST CREEK WATERSHED STUDY EXISTING DRAINAGE INFRASTRUCTURE DEFICIENCIES

For: City of Bremerton, WA

December, 2012

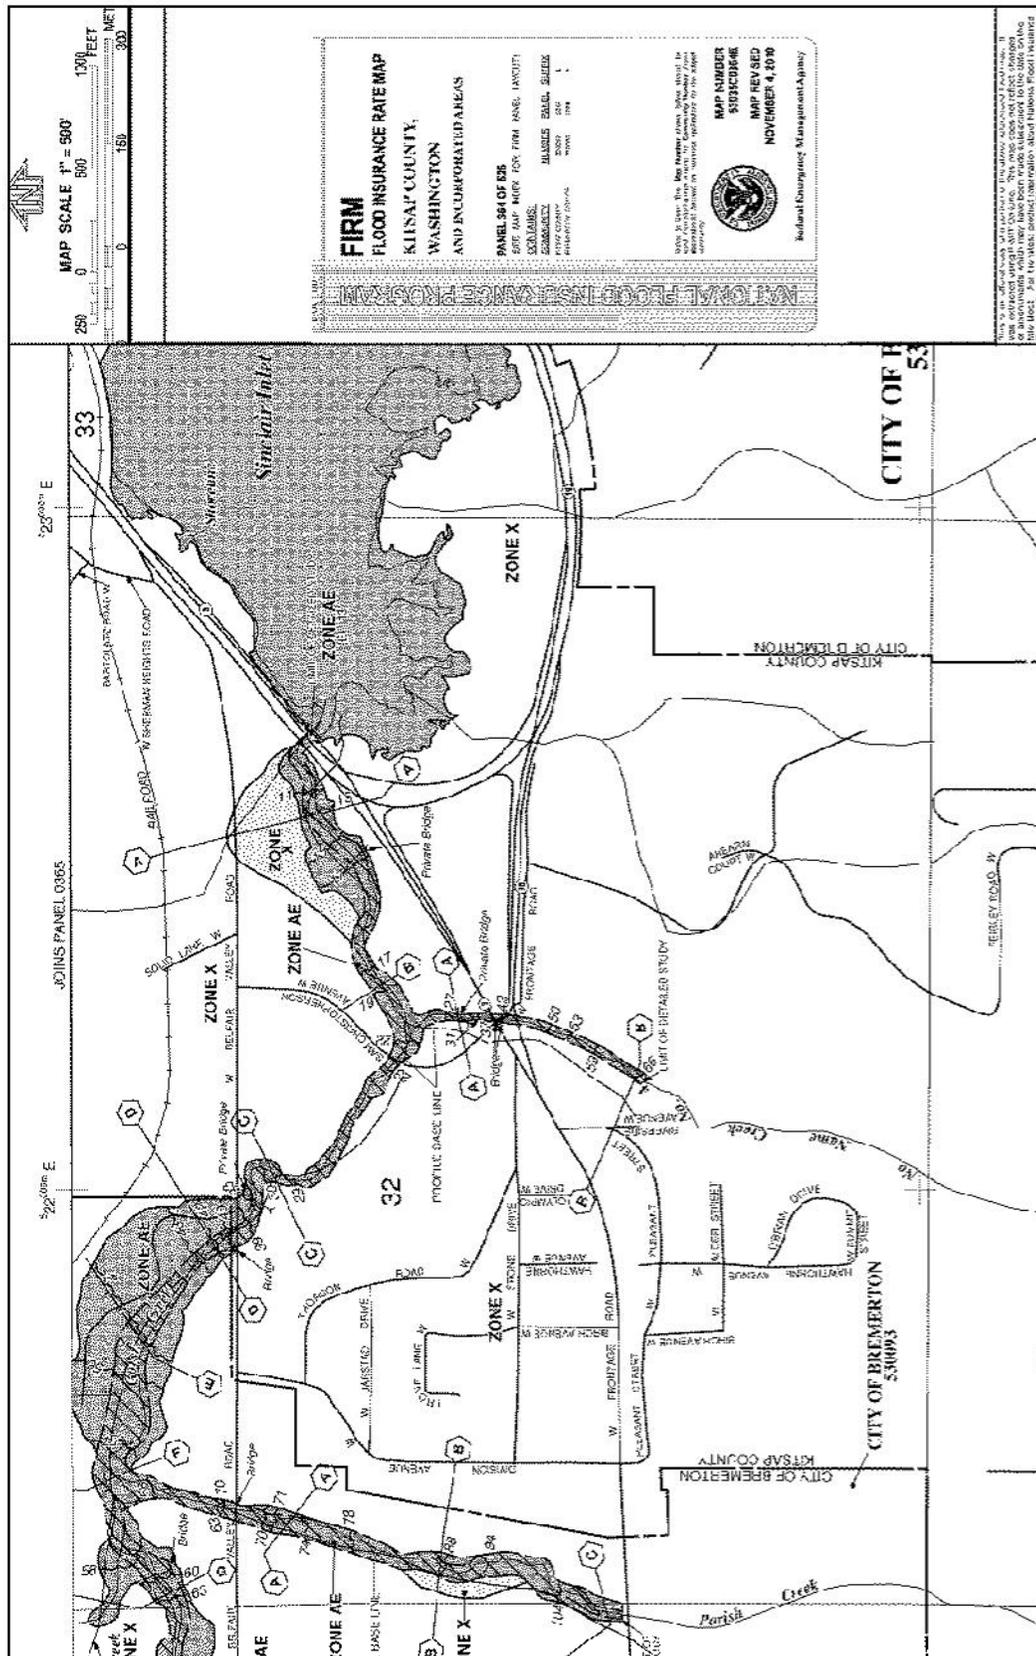
Figure 1 Gorst Creek 100 Year Flood Boundaries (draining to Sinclair Inlet)

The 100-year flood levels for the Gorst Creek Watershed are illustrated in the FEMA Flood Insurance Map shown in Figure 1. The exhibit shows a large portion of the Urban Growth Area impacted within the 100 flood plain for Gorst Creek near Sinclair Inlet.

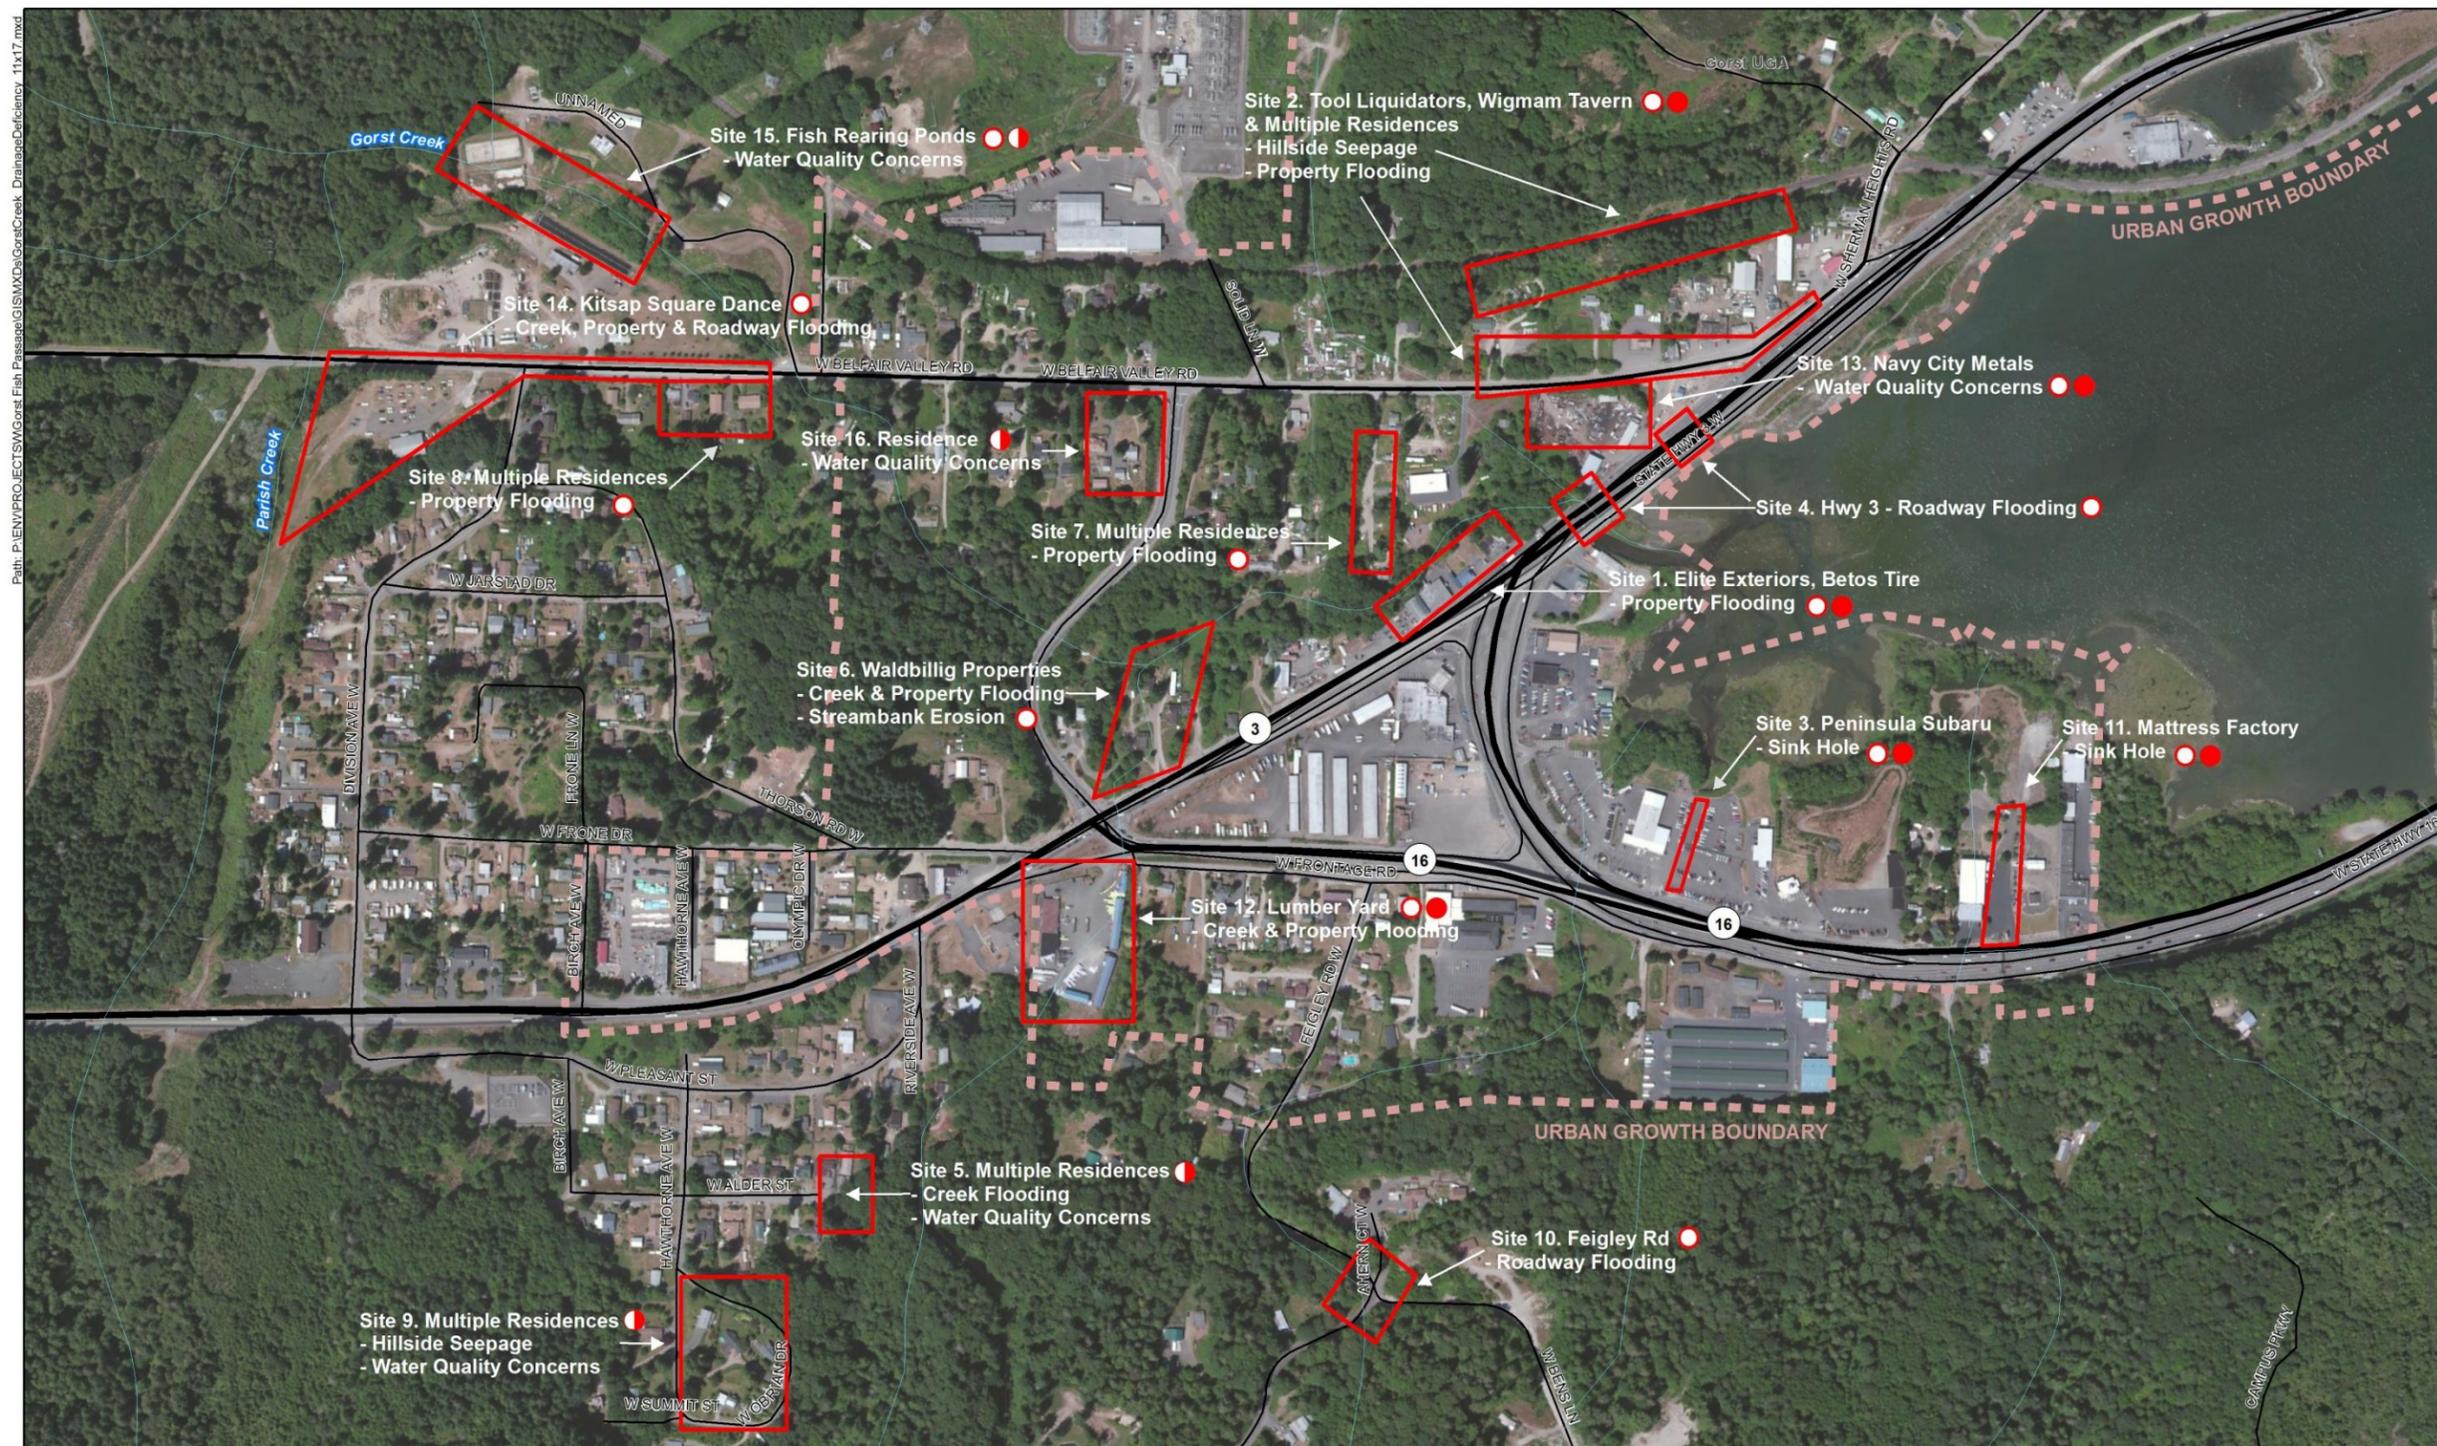
**Figure 2** Gorst Creek Identified Infrastructure Deficiencies

Drainage infrastructure deficiencies are identified by site and are located on the location map in Figure 2. General potential or observed deficiency concerns are provided in notes for each of the 16 sites in the figure. The legend identifies flooding, chemical and biological deficiency concerns for each site. All of the formal drainage complaints and records received by the County are included in Attachment B for reference. Unresolved or potential problems from the drainage complaints and records are noted in the site locations shown in Figure 2.

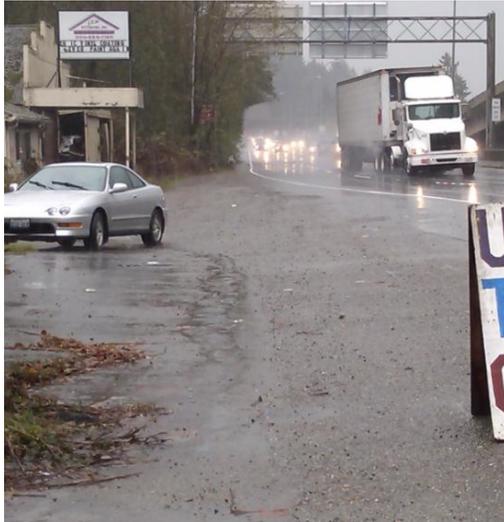
**Site 1 – Elite Exteriors and Betos Tire**, 3987 State Highway 3 W, Bremerton, WA 98312-4940. Elite Exteriors and Betos Tire are businesses located along the north side of Hwy 3, north of the viaduct. At a recent public meeting, a representative of Elite Exteriors reported frequent flooding of his commercial buildings built in 1925 and 1938. The proprietor of Betos Tire noted to me that when Hwy 3 floods during high tides and heavy rains, runoff channels along the road shoulder to a sag point in the road profile near the properties of Elite Exteriors and Betos Tires. It then floods the two properties as it drains north to Gorst Creek.

**Photo 1** Looking NW at Elite Exteriors

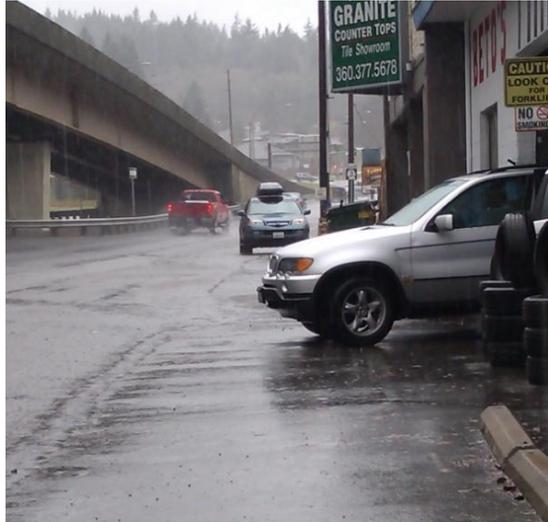
**Photo 2** Same spot looking SE along Betos Tire

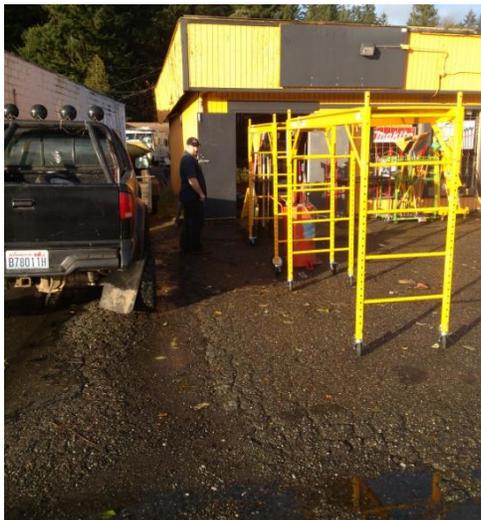
**Photo 3** Creek floods to front step of Tool Liquidators

Tool Liquidators and the Winner's Circle Bar and Grill and west adjacent residential properties reported ditch overflow flooding up to the foundation footing of their buildings during high tides and high intensity storms. Tool Liquidators has had up to 18 inches of flood waters within their building. East of the flooding, the owner of Tool Liquidators claimed that the adjacent Kitsap muffler business was not affected by the street flooding due to their raised foundation level. The west flood limits appears established by a Kitsap County Public Works drainage complaint for flooding of a driveway at 3652 W. Belfair Valley Road.

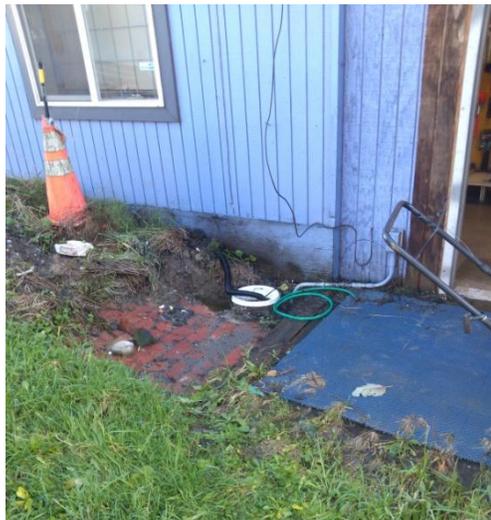
**Site 2 – Multiple business and residential sites, along W. Belfair Valley Road**, north of the Navy City Metals property. Seepage from the upland hillside flows to the back of Tool Liquidators (3476 W. Belfair Valley Road) and Winners Circle Bar and Grill (3548 W. Belfair Valley Road, or old Wigwam Tavern) after day long rains (see photo 4). The seepage can generate as much as 2 inches that has streamed through the building of Tool Liquidators. The owner has installed one sump pump and will add another at the rear of the property. From discussion with the owner of Tool Liquidators, The Winner's Circle Bar and Grill property also corrected rear property hillside drainage problems under previous ownership. The new owner has not been available to determine what specific repairs were made.

**Photo 4** Hillside seepage floods through back of Tool Liquidators

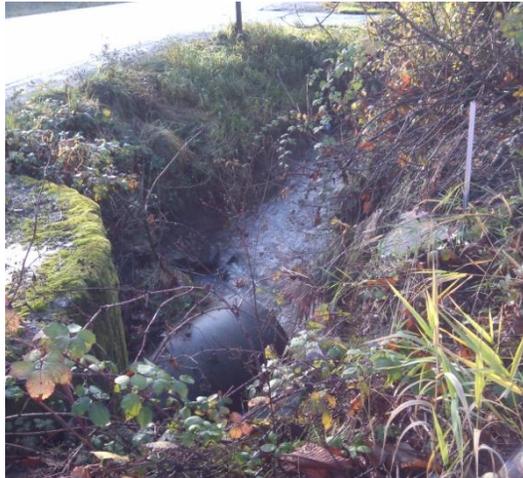
The unnamed tributary flow from the north runs east along the north side of W. Belfair Valley Road in 7' wide x 8' deep ditches and then outlets through a 36" culvert into Sinclair Inlet across Hwy 3. The ditch is overwhelmed due to rising tides and heavy rain at this roadway sag location (see photo 5). Business for Winner's Circle Bar and Grill shuts down when the road is closed by the high water and when the lot floods (see photo 6).

**Photo 5** Belfair Valley Road 36 IN Culvert crosses roadway at Wigwam Tavern

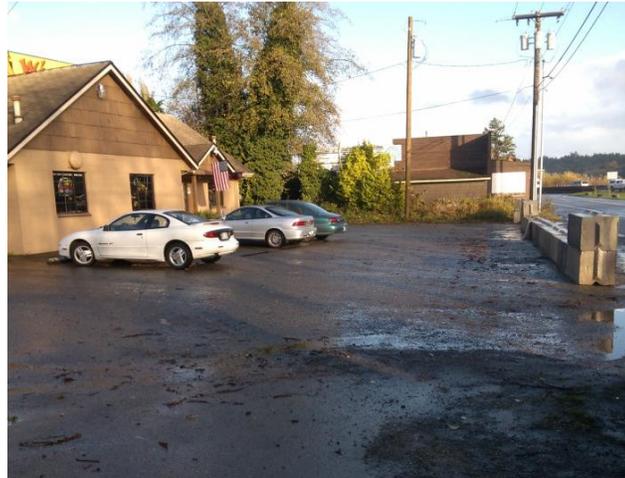
**Photo 6** Winner's Circle Bar and Grill flooded to doorstep and flooded parking lot

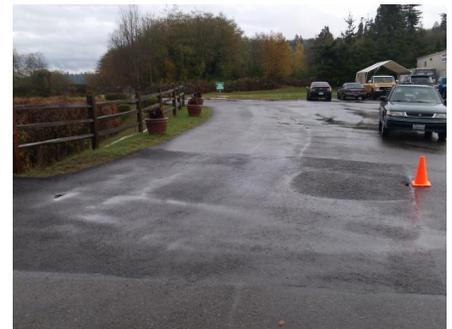
**Photo 7** Patched sink hole location

The owner has tried to correct two previous sink holes by repairing the drain line for the parking lot drainage (see photo 7) until it was discovered that a second CMP drain line next to it was causing the sink holes. The second CMP culvert pipe runs through the lot. The outlet for this pipe is set lower and includes a tee diffuser. A

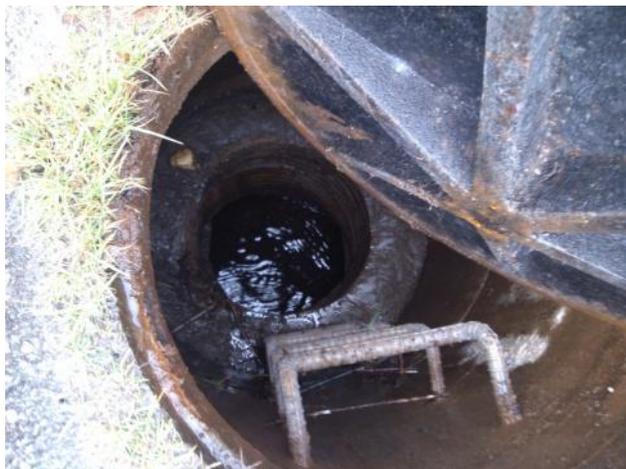
manhole on the south side of Peninsula Subaru was opened and inspected. It connects an 18" CMP WSDOT culvert crossing Hwy 3 with the culvert within Subaru (see photo 8). An unnamed tributary from the south is drained by these culvert pipes into Sinclair Inlet. The CMP culvert within Subaru has corroded and the sink holes are likely the result of culvert piping or exterior flows undermining and eroding out the bedding around the pipe.

**Photo 8** Manhole in Subaru parking where roadway storm drain connects

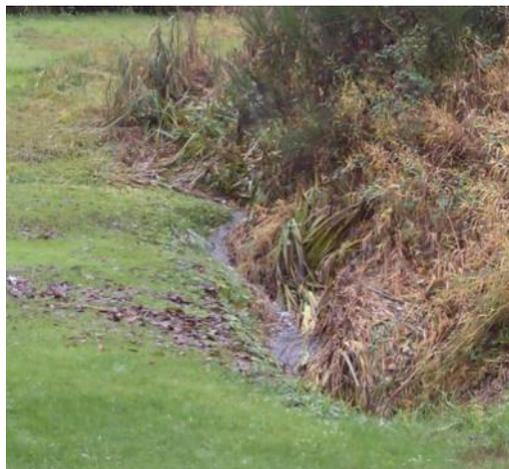
**Photo 9** Tributary south of Hwy 3

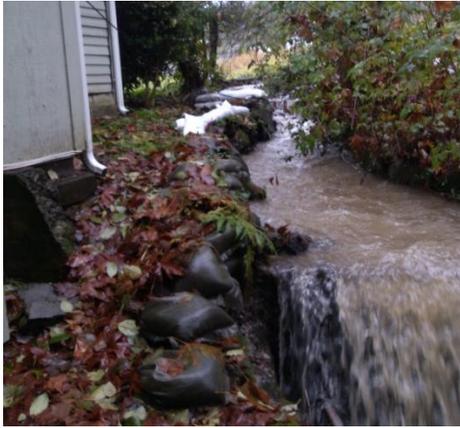
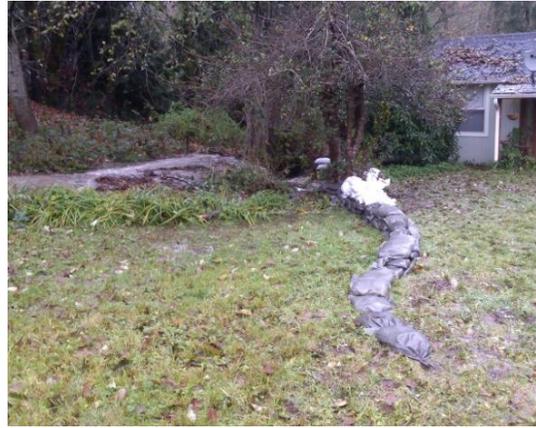
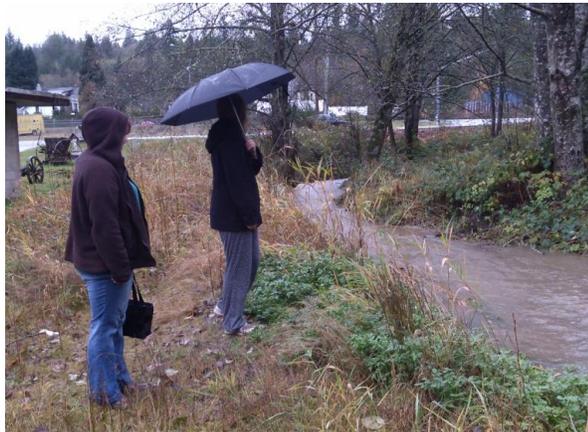
**Site 6 – Waldbillig Properties**. These properties include the residences of 4159 and 4177 Hwy 3 and a commercial property at 4163 Hwy 3 that are all located on the north side of the highway and east of Sam Christopherson Avenue W. A 24" culvert beginning at the Washington Cedar lumber yard crosses the intersection and outlets on the upstream southern property point on Waldbillig Properties. A ditch carries this outflow to the west side of the property and then drains north to Gorst Creek. This perched elevated ditch overtops its banks and floods both homes. The ditch adjacent to the affected homes on the west side requires sandbagging to contain ditch flows (see photos 10 through 13).

**Photo 10** Waldbillig Property looking south at unnamed tributary

**Photo 11** Looking north (tributary on left)

**Photo 12** Looking south

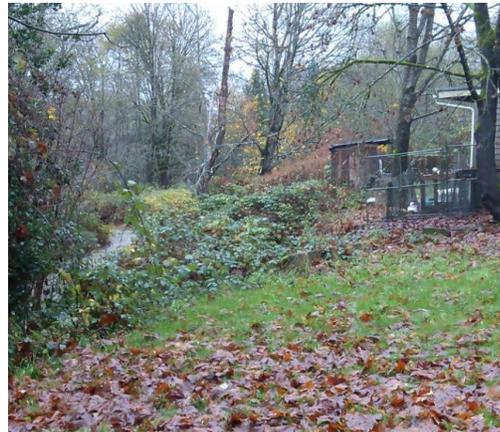
The Kitsap Public Health District thought that the owner claimed that the residence at 4159 Hwy 3 was almost lost to streambank erosion in Gorst Creek three to four years ago.

**Photo 13** Gorst stream bank at Waldbillig property at 4159 Hwy 3

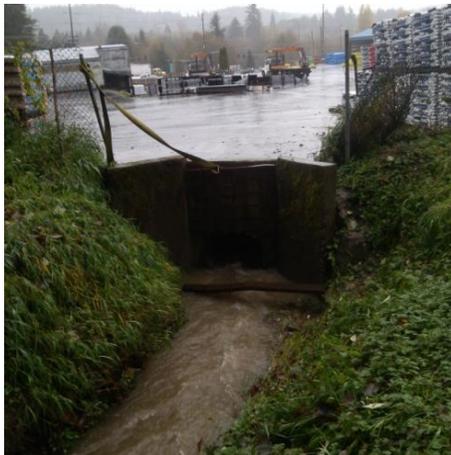
**Site 12 – Washington Cedar lumber yard**, 4041 Hwy 3 W, Bremerton (junction of Hwy 16 and Hwy 3). Kitsap Public Works and the Kitsap Public Health District noted previous flooding from an upstream unnamed tributary that caused property damage in the lumber yard from an overwhelmed culvert entrance upstream of the parking lot edge. Flows enter the site from an upstream unnamed creek from the south (see photo 14). To avoid flooding, the manager has to maintain a screen at the culvert entrance that prevents debris from entering the 24-inch culvert pipe. Silt has not been an issue with the 24-inch culvert.

**Photo 14** Culvert entrance at the upstream edge of the lumber yard

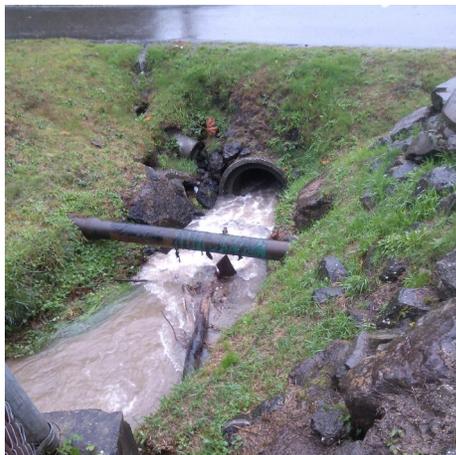
**Photo 15** Culvert entrance at the downstream edge of lumber yard

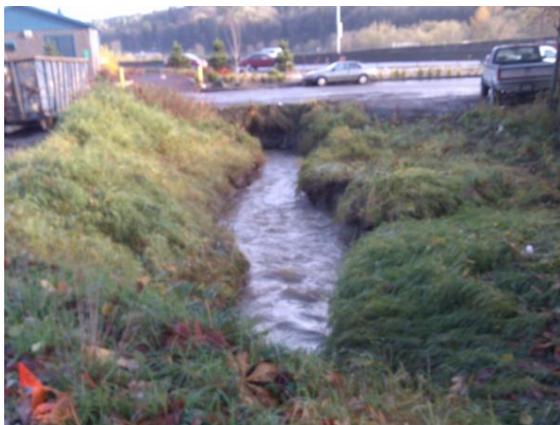
**Site 13 – Navy City Metals, 3805 Hwy 3 W. Bremerton.** This site is monitored by the Department of Ecology through an industrial permit. The ditch on the north side of W. Belfair Valley Road (see photo 5) is connected to a second continuing downstream ditch by a 36” culvert crossing under the road. This ditch is drained by a 36” culvert crossing Hwy 3 to Sinclair Inlet. The second ditch (see photo 16) is adjacent to this active metal recycling facility. Backwater from high tides and heavy rainfall floods the properties noted in Site 2 and the yard at Navy City Recycling. Employees report that flooding as deep as 3 feet has been seen in the yard. All yard drainage leaves through an oil water separator and is released into the ditch by a 6-inch pipe. Metal laden runoff released into Sinclair Inlet is a concern where copper and zinc levels are already high.

**Photo 16** Ditch and 36” culvert crossing at Hwy 3

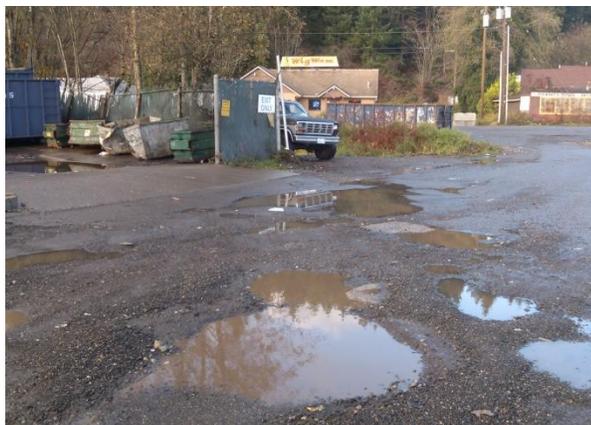
**Photo 17** Looking north at ditch and Wigwam in background and Navy City Recycle’s north drive is shown on the left

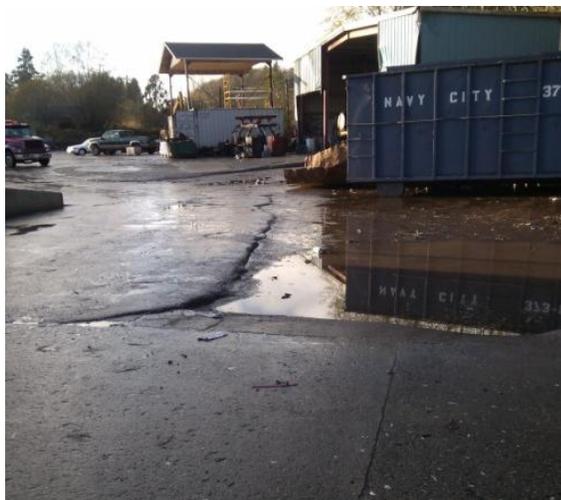
**Photo 18** North drive of Navy City Recycle

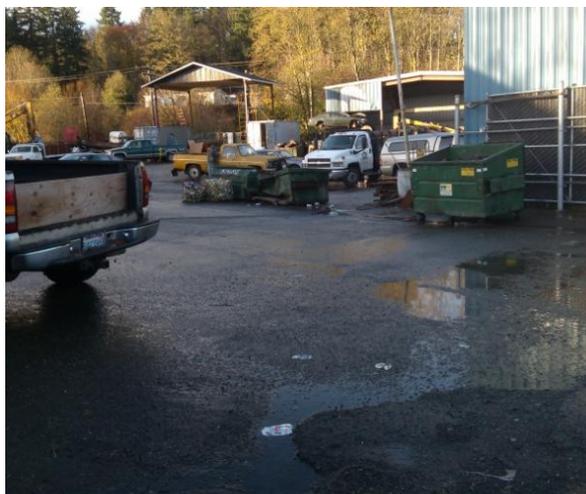
**Photo 19** South drive of Navy City Recycle

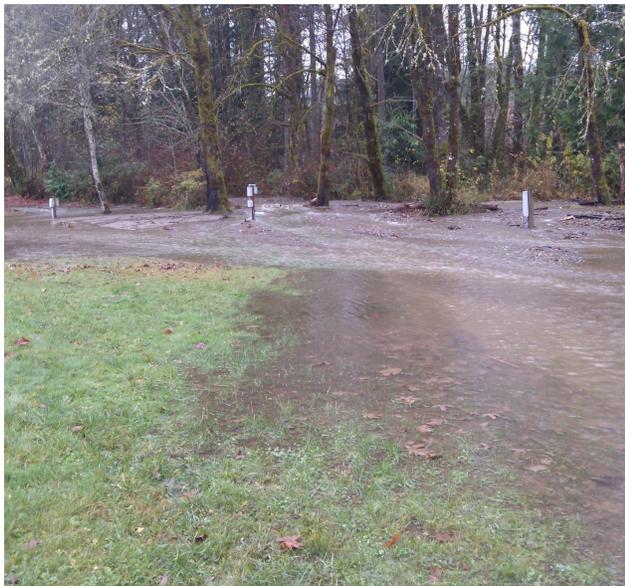
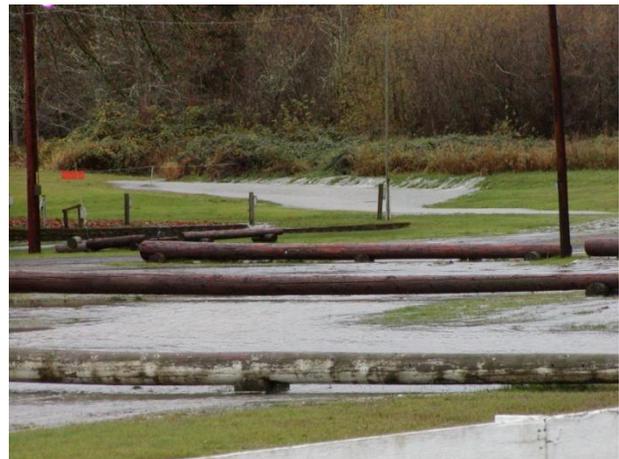
**Site 14 –Kitsap Square Dance Association, 6800 W. Belfair Valley Road, Gorst, WA** (Outside Urban Growth Area). The Parish Creek sub-basin drainage area is 1.8 square miles. Parish Creek flows northward beneath Highway 3 west of Division Street and crosses beneath the West Belfair Valley Road just before joining Gorst Creek. During high flows, Parish Creek jumps the narrow and shallow creek bed channel into surrounding floodplain areas to the east, approximately 400 feet upstream of the West Belfair Valley Road culvert. The stream channel profile and surrounding area grade changes within the area of the Kitsap Square Dance Hall facility and becomes quite flat. Over the years, high flow events have brought sediment into this area causing loss of the main channel due to filling, and creating braiding and broad floodplain overflows into the adjacent

areas (see photos 20 and 21). From this location, floodplain drainage tends to flow through the Kitsap Square Dance Association gravel parking lot to the NE corner. In the past four storms within seven years, the sheet flow from the dance hall facility washes over W. Belfair Valley Road and down both road shoulders toward the roads sag point at the Gorst Creek crossing, 800' to the east. West of the dance hall facility, the main Parish Creek channel flows through a 5-foot diameter CMP culvert under the West Belfair Valley Road.

**Photo 20** Creek bank overflow from behind first row of trees upstream of the Association's property

**Photo 21** Creek and floodplain overflow onto the Association's property

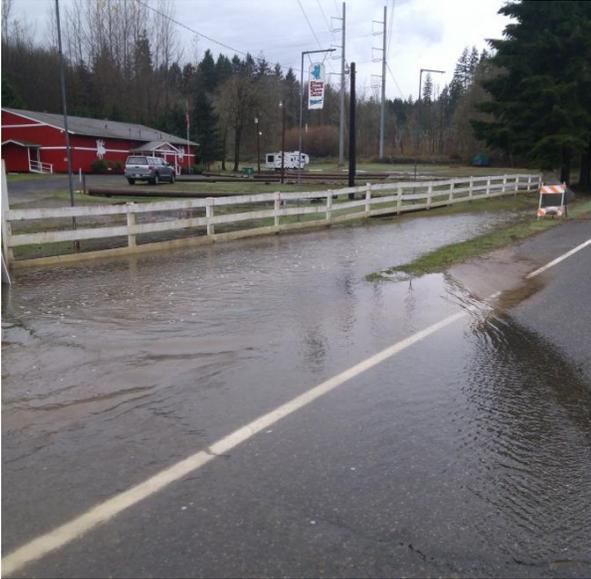
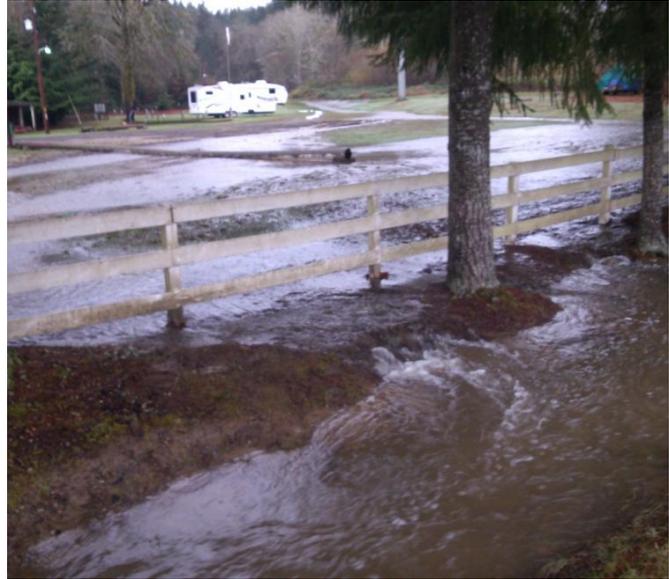
Flooding flows down W. Belfair Valley Road significantly erode the four to eight foot gravel shoulders and threatens to flood approximately three homes on the south side near Gorst Creek (see photos 24 and 25). The cost of pumping as much as 50,000 gallons of water in the crawlspace of the dance hall and replacement of gravel in the parking lot is absorbed by the Association after each one of these storm events (see photos 22 and 23).

**Photo 22** Kitsap Square Dance Association parking

**Photo 23** Runoff overtops Belfair Valley Road

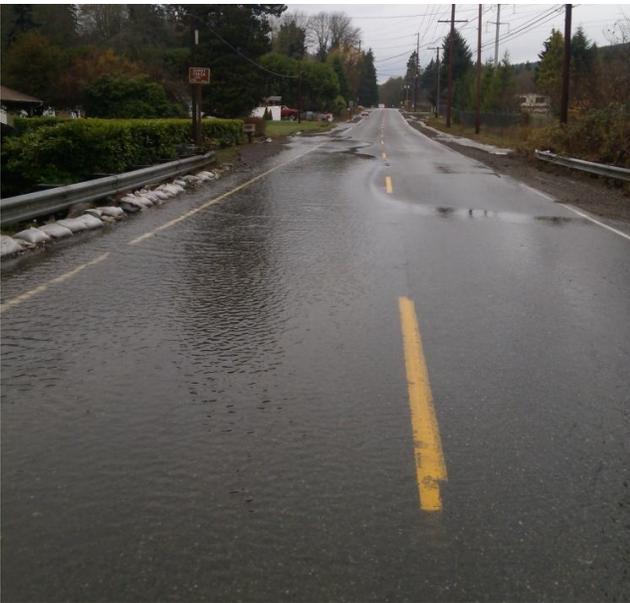
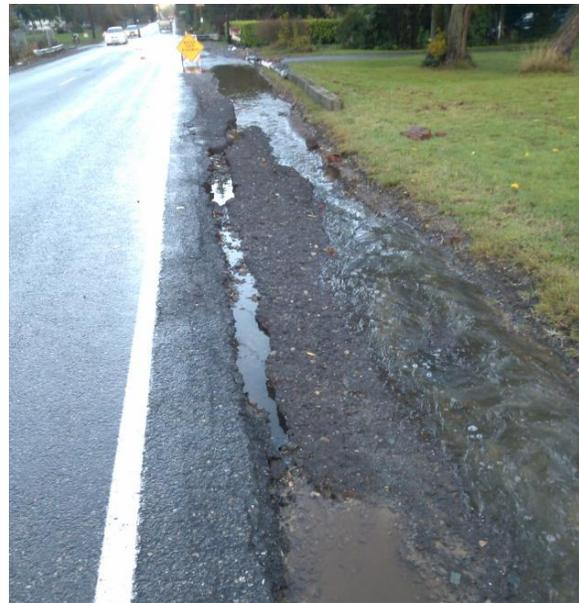
**Photo 24** Belfair Valley Road at Gorst Creek 800' away

**Photo 25** Sandbags along property and shoulder erosion
