## TECHNICAL MEMORANDUM

### GORST CREEK WATERSHED STUDY EXISTING DRAINAGE INFRASTRUCTURE DEFICIENCIES

For: City of Bremerton, WA

December, 2012

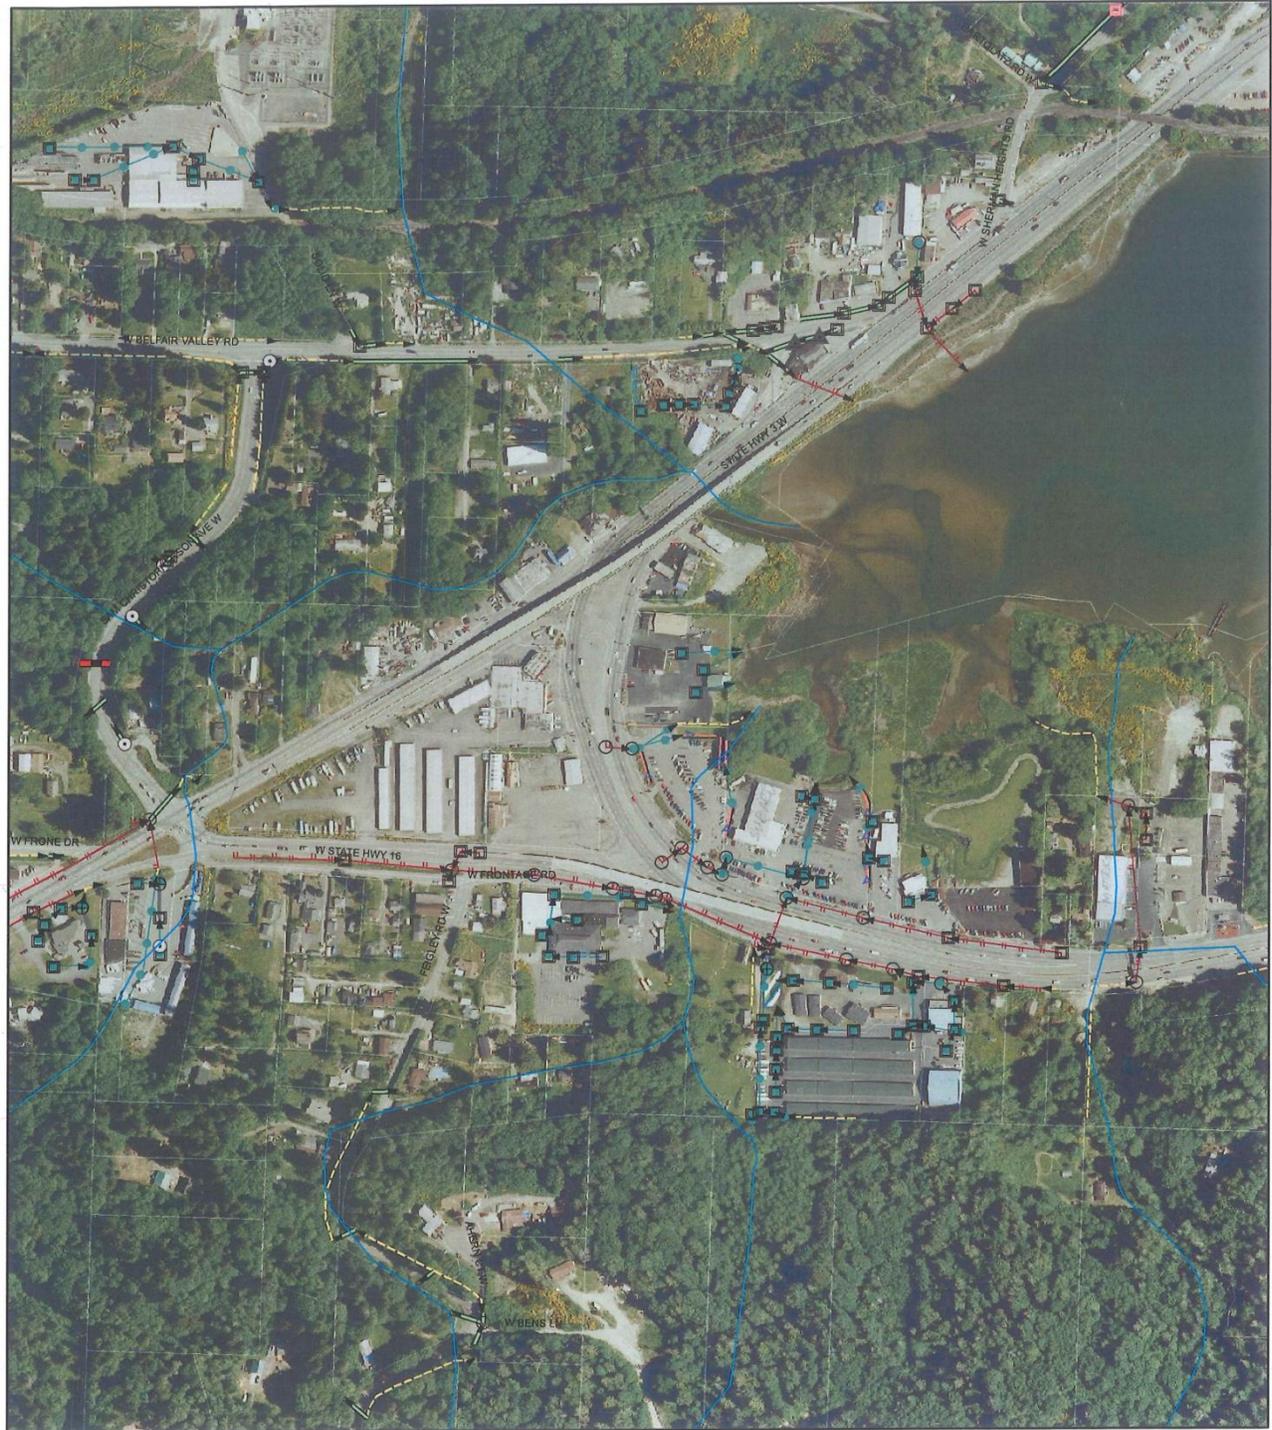
**Figure 2** Gorst Creek Identified Infrastructure Deficiencies

Drainage infrastructure deficiencies are identified by site and are located on the location map in Figure 2. General potential or observed deficiency concerns are provided in notes for each of the 16 sites in the figure. The legend identifies flooding, chemical and biological deficiency concerns for each site. All of the formal drainage complaints and records received by the County are included in Attachment B for reference. Unresolved or potential problems from the drainage complaints and records are noted in the site locations shown in Figure 2.
